# Derailment of Cairns Tilt Train VCQ5

North of Berajondo, Queensland  
15 November 2004

RAIL SAFETY INVESTIGATION  
QT1472

**Derailment of Cairns Tilt Train VCQ5**  
**North of Berajondo, Queensland**  
**15 November 2004**

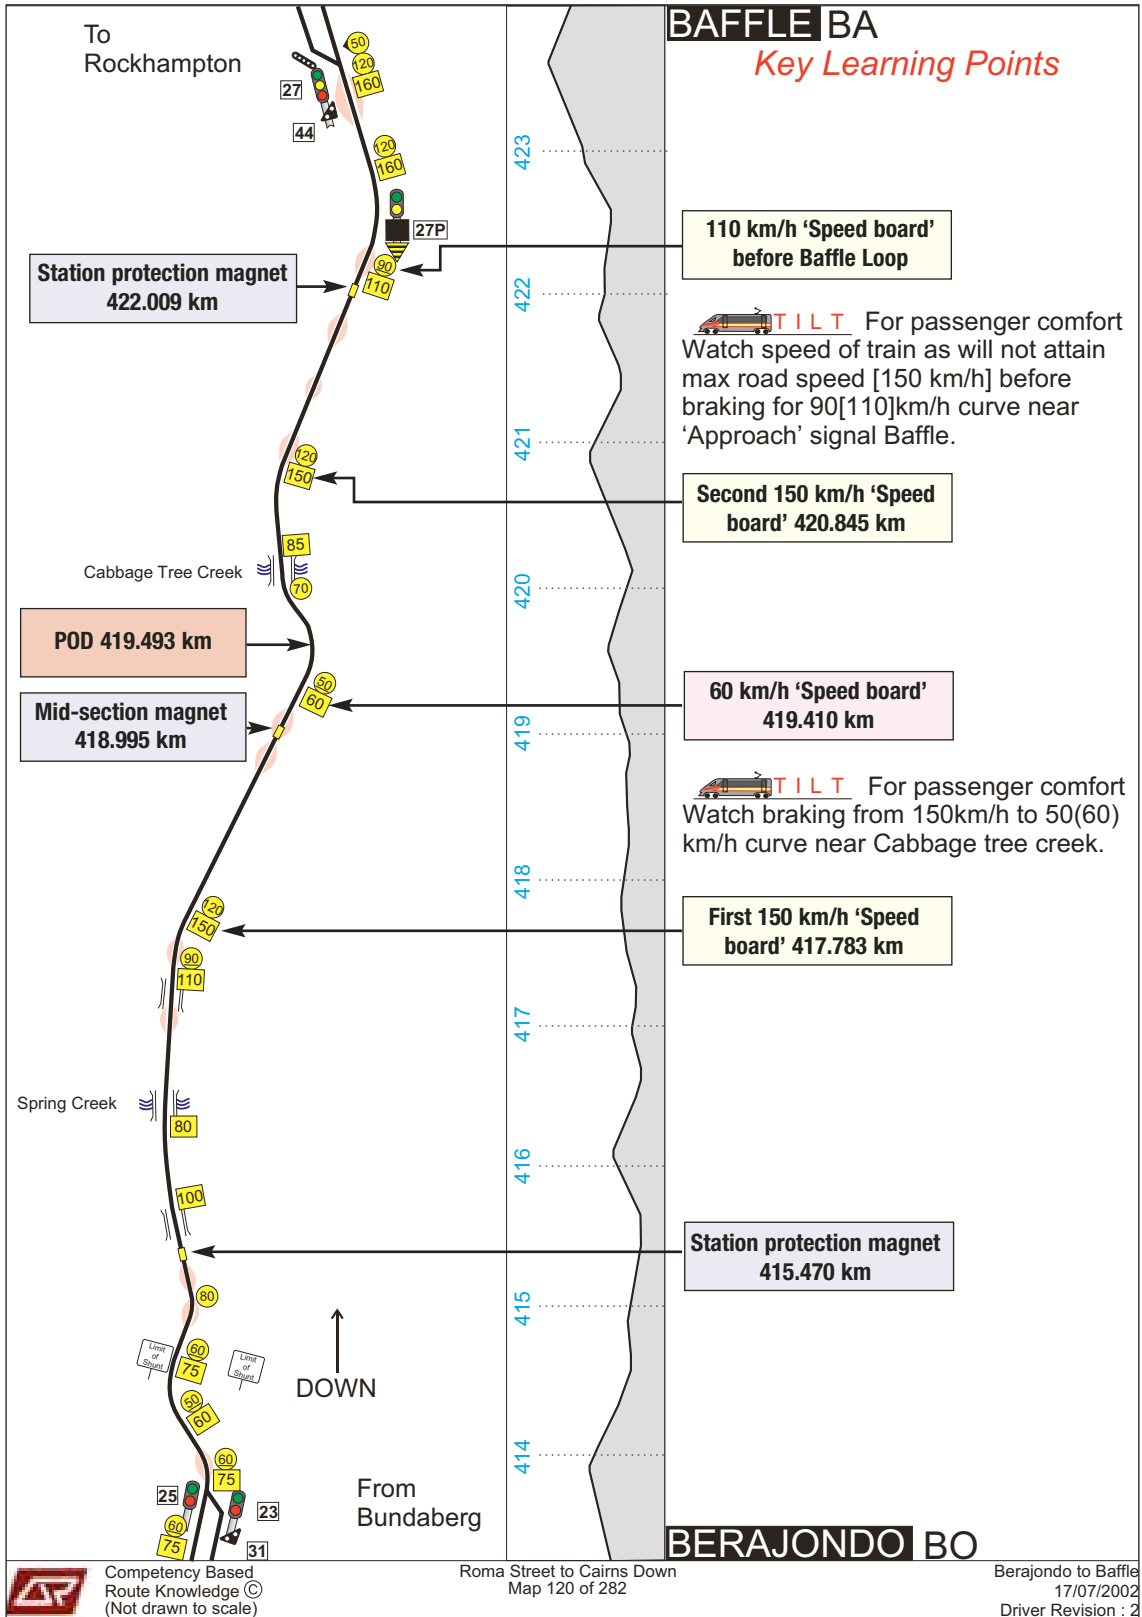
FIGURE 2: QR Route Map, Berajondo to Baffle

The section of track from Bundaberg through to Gladstone (Fig. 2) comprises a single line with 'passing loops' to facilitate the crossing of trains. There is a 'passing loop' at Berajondo (413.5 km) and Baffle (424.2 km). The track between the two 'passing loops' is undulating with nine curve sections linked by straights. Speeds of up to 150 km/h are permitted over two straight sections, the first starting at 417.783 km and the second at 420.854 km respectively; however there is a need to significantly reduce speed to 60 km/h at 419.410 km before a series of curves in advance of Cabbage Tree Creek.

The site of the derailment was on the first 60 km/h curve commencing at 419.411 km. The accident site was contained by soft earth embankments with the right-of-way bounded by a stock-proof fence; low level undergrowth existed within the right-of-way, with fairly young eucalypt trees located close to the boundary fence. Good access was available at the accident site, from the adjacent Bundaberg to Lowmead Road.
